## LCD TELEVISION TECHNICAL BULLETIN

<b><u>MODELS</u></b>	LC32SA1E LC32BT8E	LC32SD1E	LC32GA8E	LC32GD8E
----------------------	----------------------	----------	----------	----------

Reference – LV260  
Revision - 1

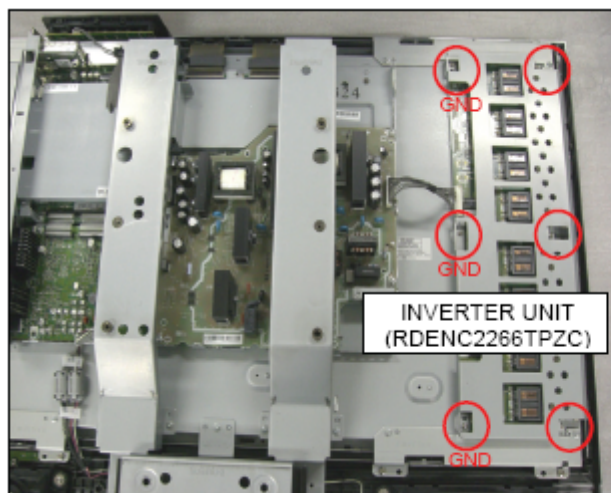
**SYMPTOM** Backlight intermittently shuts down leaving sound on.

**CAUSE** Poor earth contact on Inverter panel.

**ACTION** Replace all 6 fixing screws with the improved type.

Procedure:  
Change the 6 screws to LX-BZ2315TPZZ.

OLD PARTS:  
LX-BZ2090TPZZ  
M3 x 6mm

NEW PARTS:  
LX-BZ2315TPZZ  
M3 x 7mm  
φ 8 washer

(Do NOT reuse the removed old screws.)
